# **EVALUATION OF HIGH STRENGTH COLUMBIUM ALLOYS FOR ALKALI METAL CONTAINMENT**

**INTERIM REPORT NO. 2**

**Covering the Period  
July 25, 1962 to July 10, 1964**

**SPACE POWER AND PROPULSION SECTION  
MISSILE AND SPACE DIVISION**

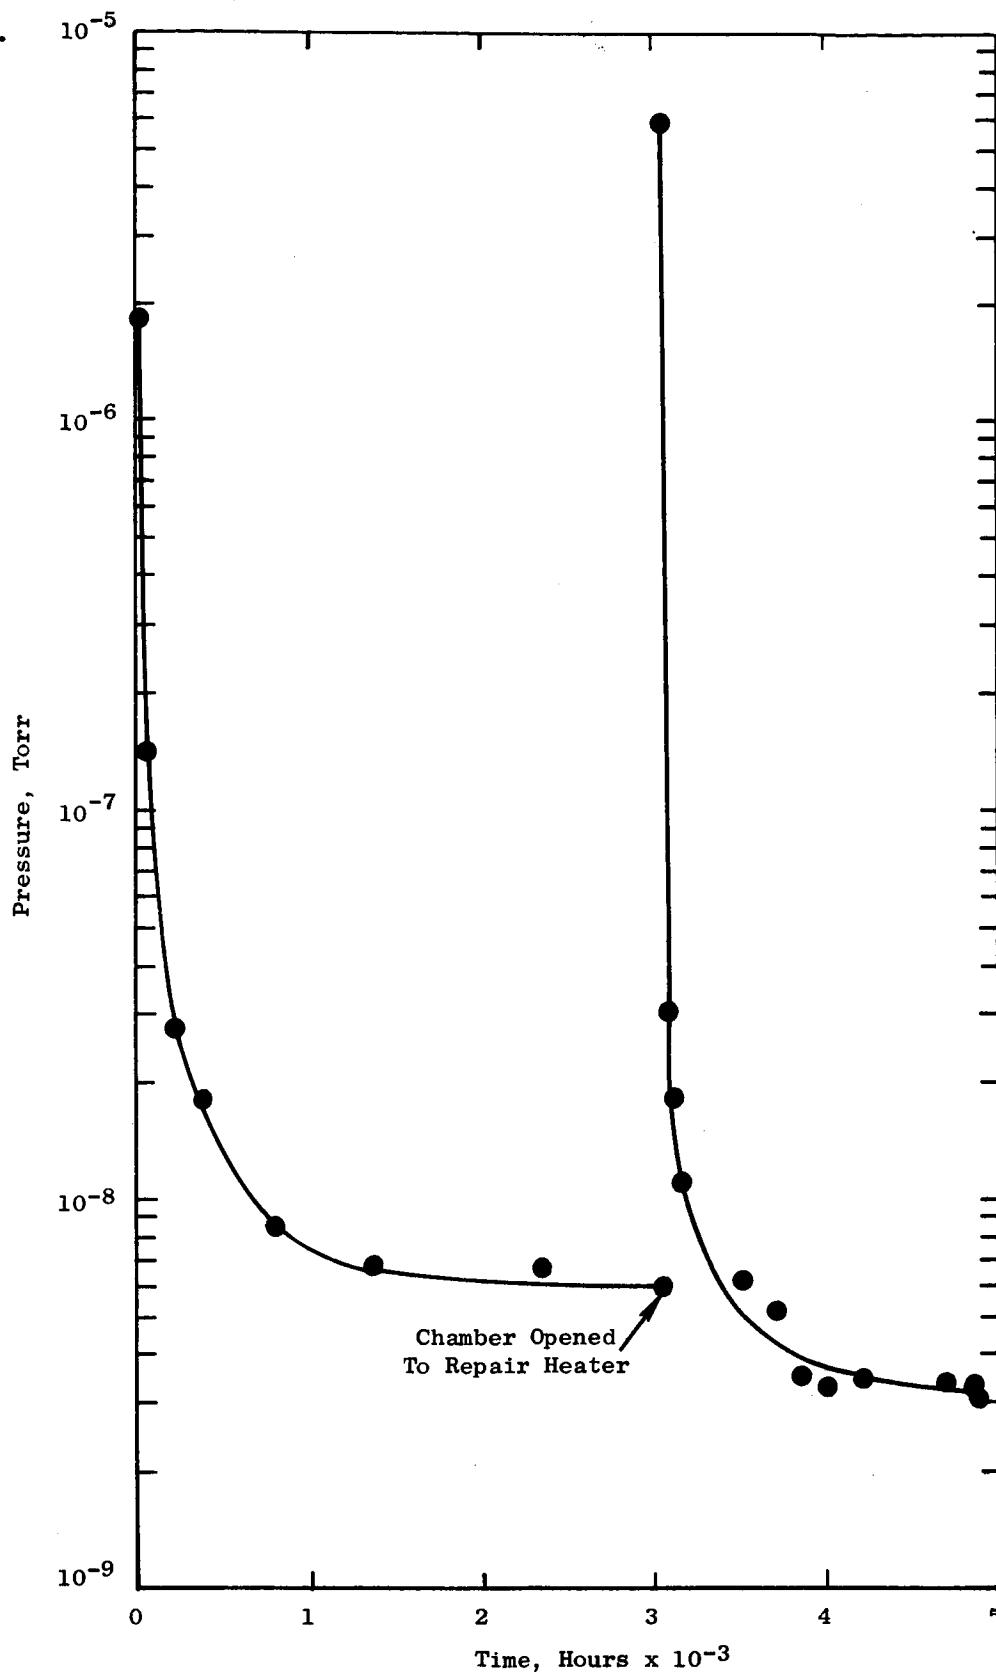
Figure 15. Pressure Profile of High-Vacuum Chamber C-II During Testing of AS-55 Alloy Reflux Corrosion Capsule #12 and D-43 Alloy Reflux Corrosion Capsule #2 at 2000°F for 5,000 Hours.

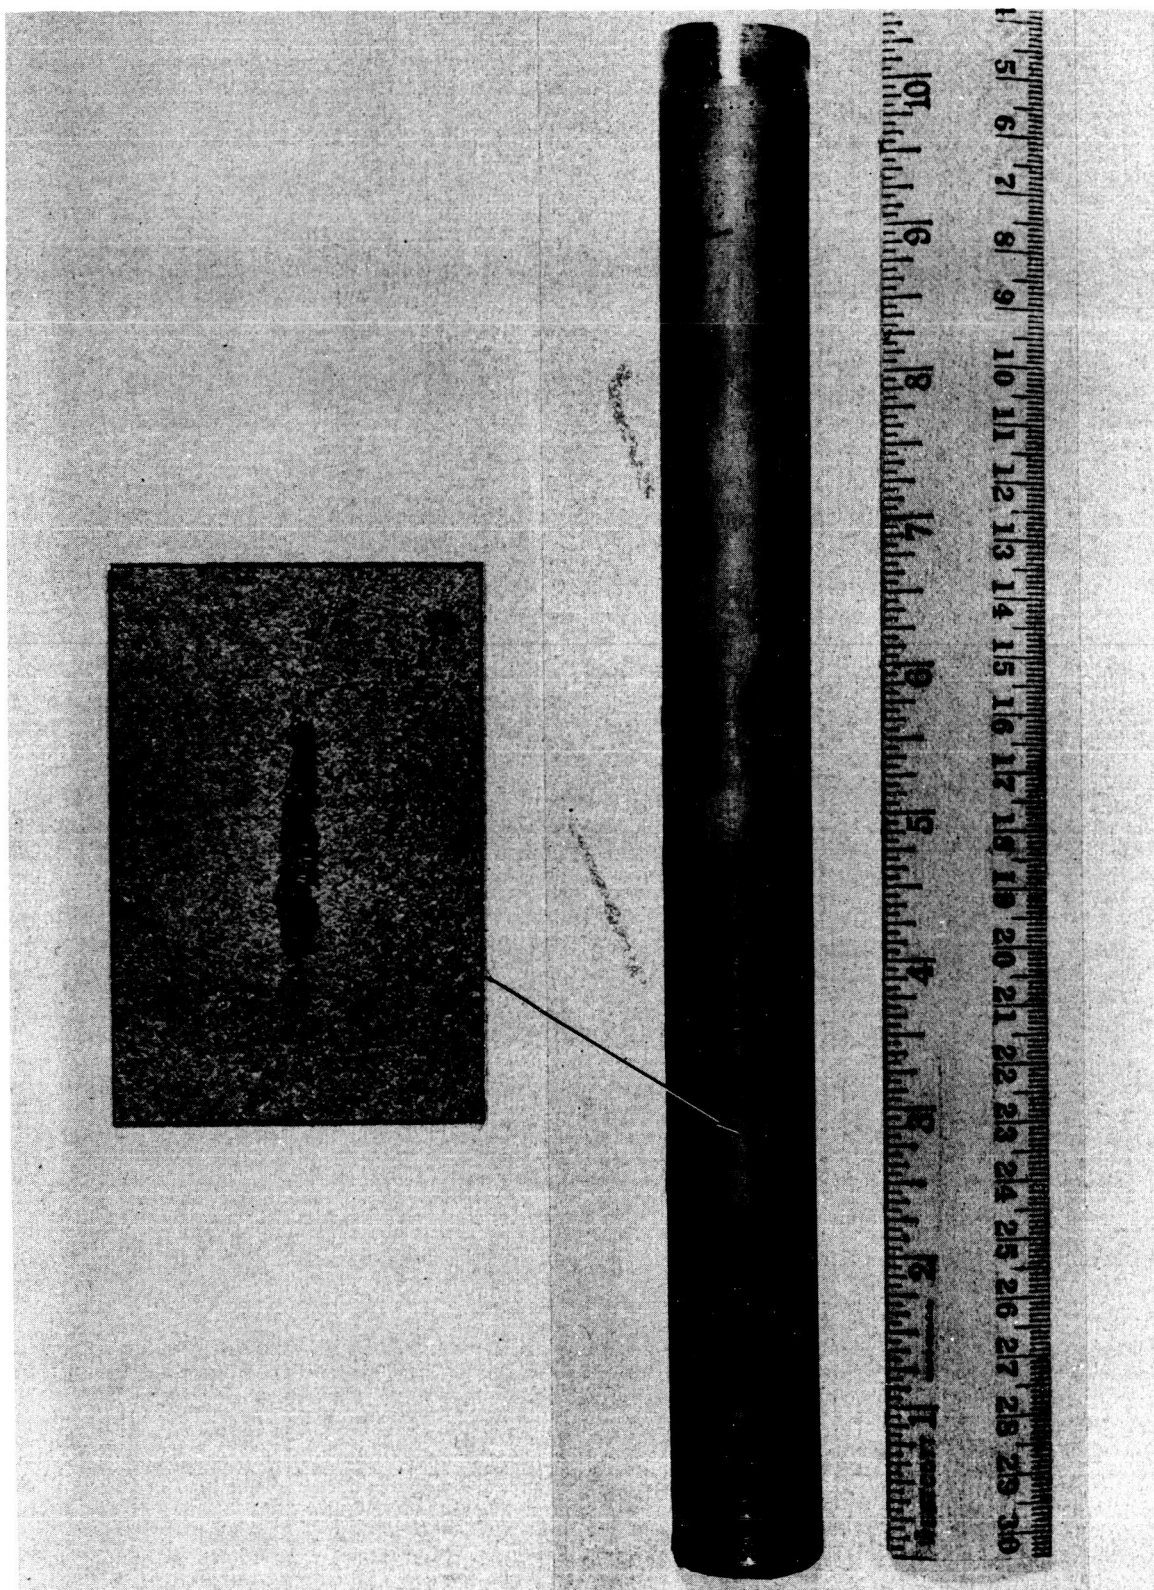
Figure 16. AS-55 Alloy Reflux Corrosion Capsule #12 After a 5,000-Hour Exposure to Potassium at 2000°F in a Vacuum of  $10^{-9}$  Torr. Note Bonding of Tantalum Thermocouple Sheath to Capsule at Thermocouple Junction. Left: Mag: 16X (C64012206); Right: (C64012208)

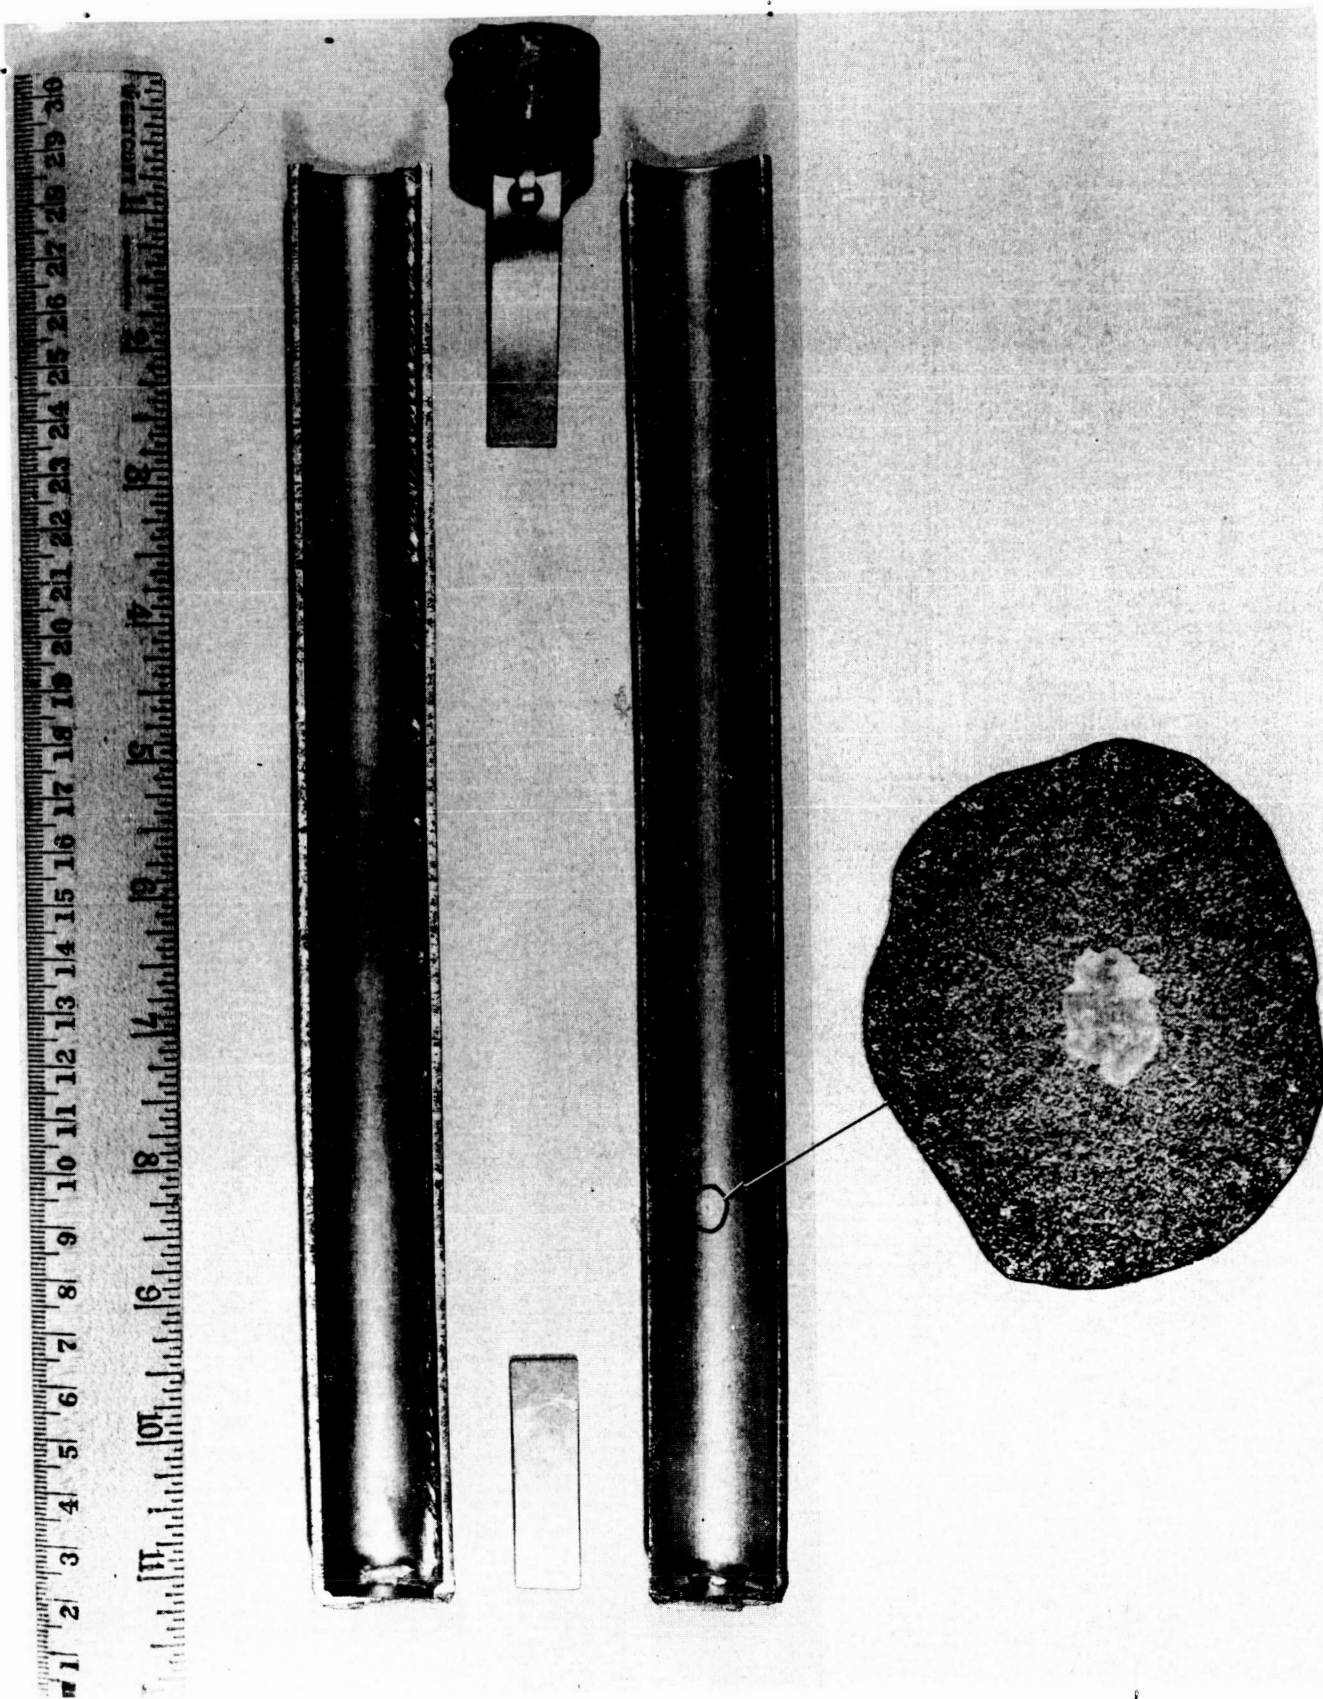
Figure 17. Sectioned AS-55 Alloy Reflux Corrosion Capsule #12 After a 5,000-Hour Exposure to Potassium at 2000°F in a Vacuum of  $10^{-9}$  Torr. Note the Deposit on the Inside Wall Opposite the Location of the Thermocouple Junction Bond. Right: Mag: 16X (C64012205); Left: (C64012207)

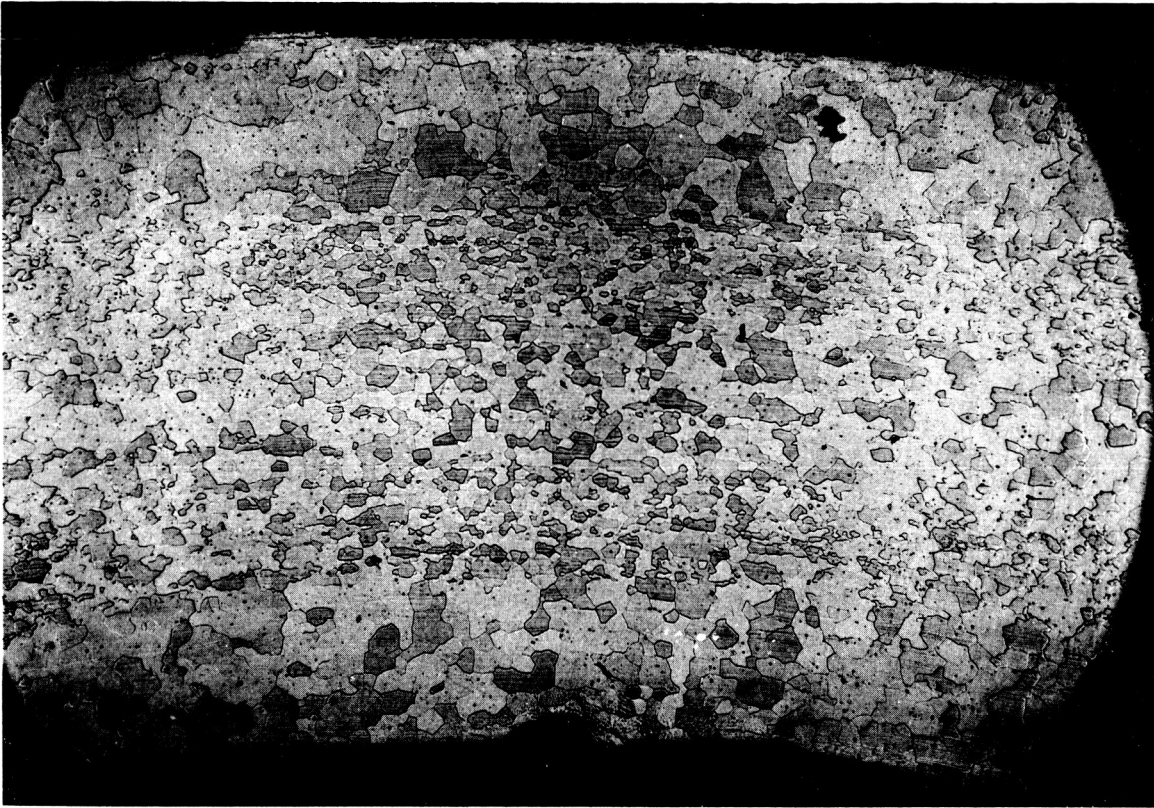
Figure 18. Microstructure of Transverse Section Through Liquid Region of AS-55 Reflux Corrosion Capsule #12 After a 5,000-Hour Exposure to Potassium at 2000°F in a Vacuum of  $10^{-9}$  Torr. Note Bonding of Tantalum Thermocouple Sheath on External Surface. Mag: 50X (K4708) Etchant: 20% $\text{Hf}$ -20% $\text{HNO}_3$ -60% $\text{H}_2\text{O}$ .

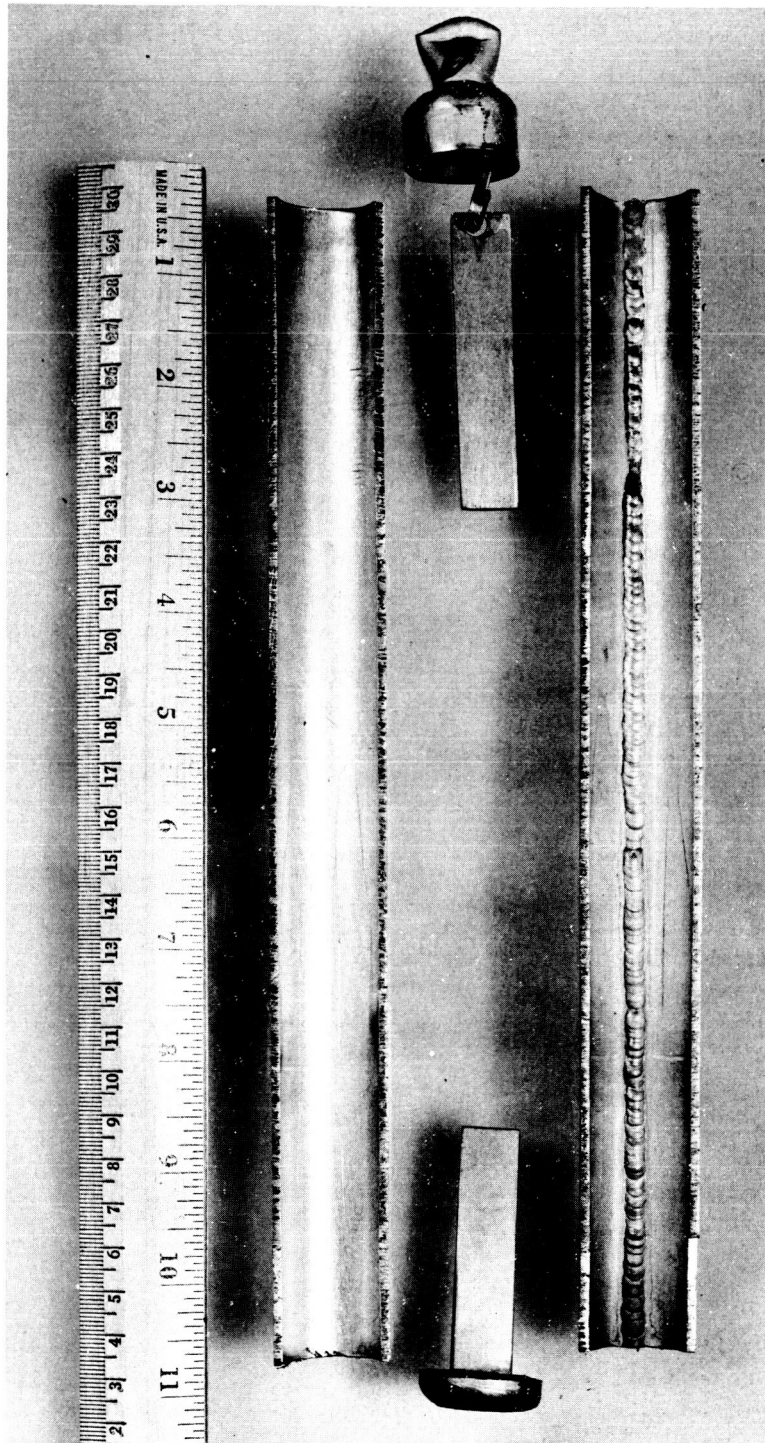
Figure 19. Sectioned AS-55 Alloy Reflux Corrosion Capsule #8 After a 5,000-Hour Exposure to Potassium at 2000°F in a Vacuum of  $10^{-9}$  Torr. (C63071113)

Visual examination of the inside surfaces of the AS-55 alloy capsule #8 and Cb-1Zr alloy capsule #6, Figures 19 and 20, revealed:

1. Discolorations in the region between the primary condensing zone and the liquid zone,
2. a change in surface appearance in the heat affected-zone of the weld, and
3. in general, a more lustrous appearance above the liquid region.

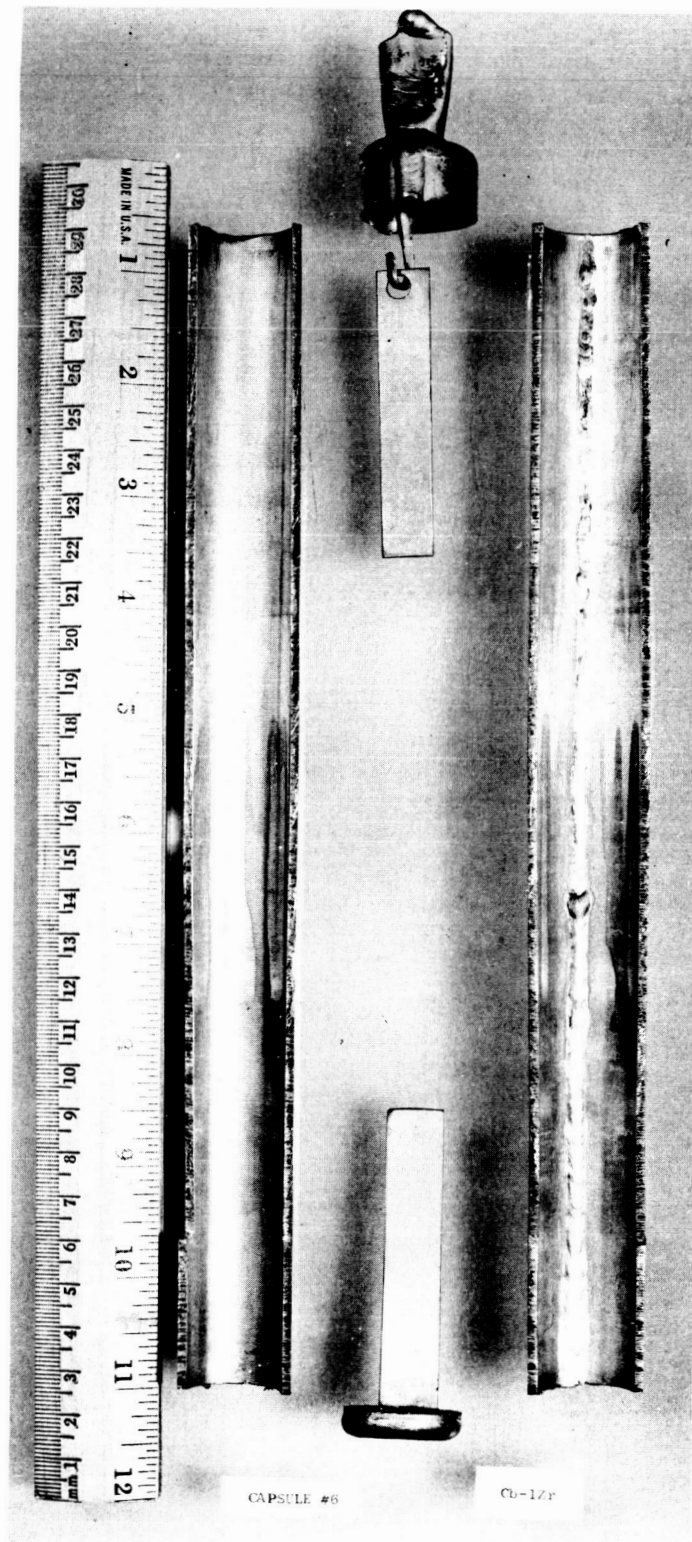
Figure 20. Sectioned Cb-1Zr Alloy Reflux Corrosion Capsule #6 After a 5,000-Hour Exposure to Potassium at 2000°F in a Vacuum of  $10^{-9}$  Torr. (C63071114)

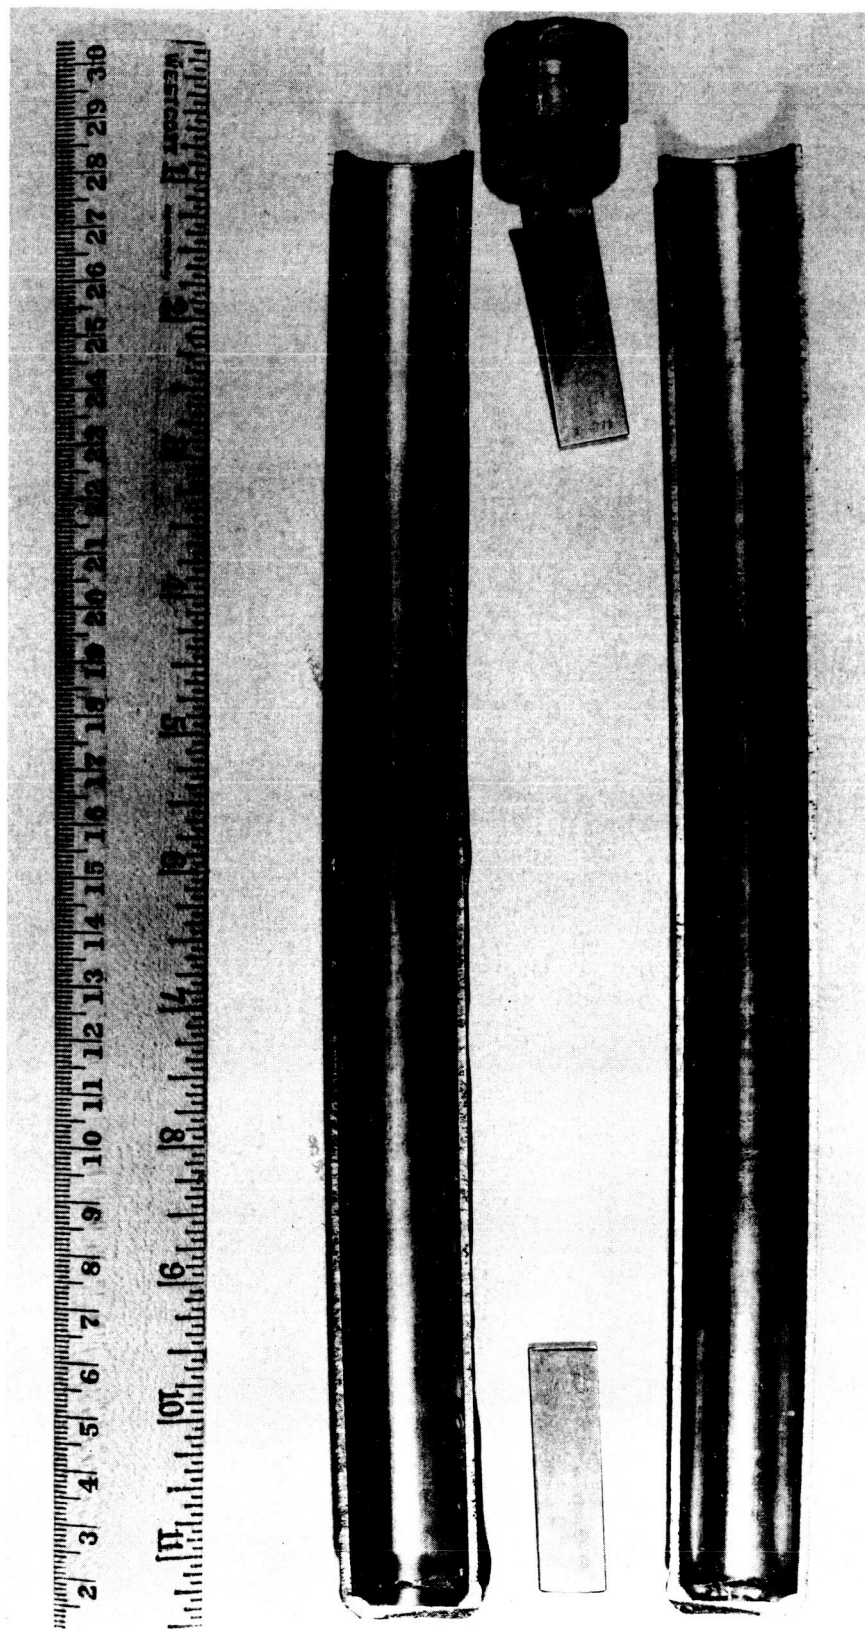
Figure 21. Sectioned D-43 Alloy Reflux Corrosion Capsule #2 After a 5,000-Hour Exposure to Potassium at 2000°F in a Vacuum of  $10^{-9}$  Torr. (C64012209)

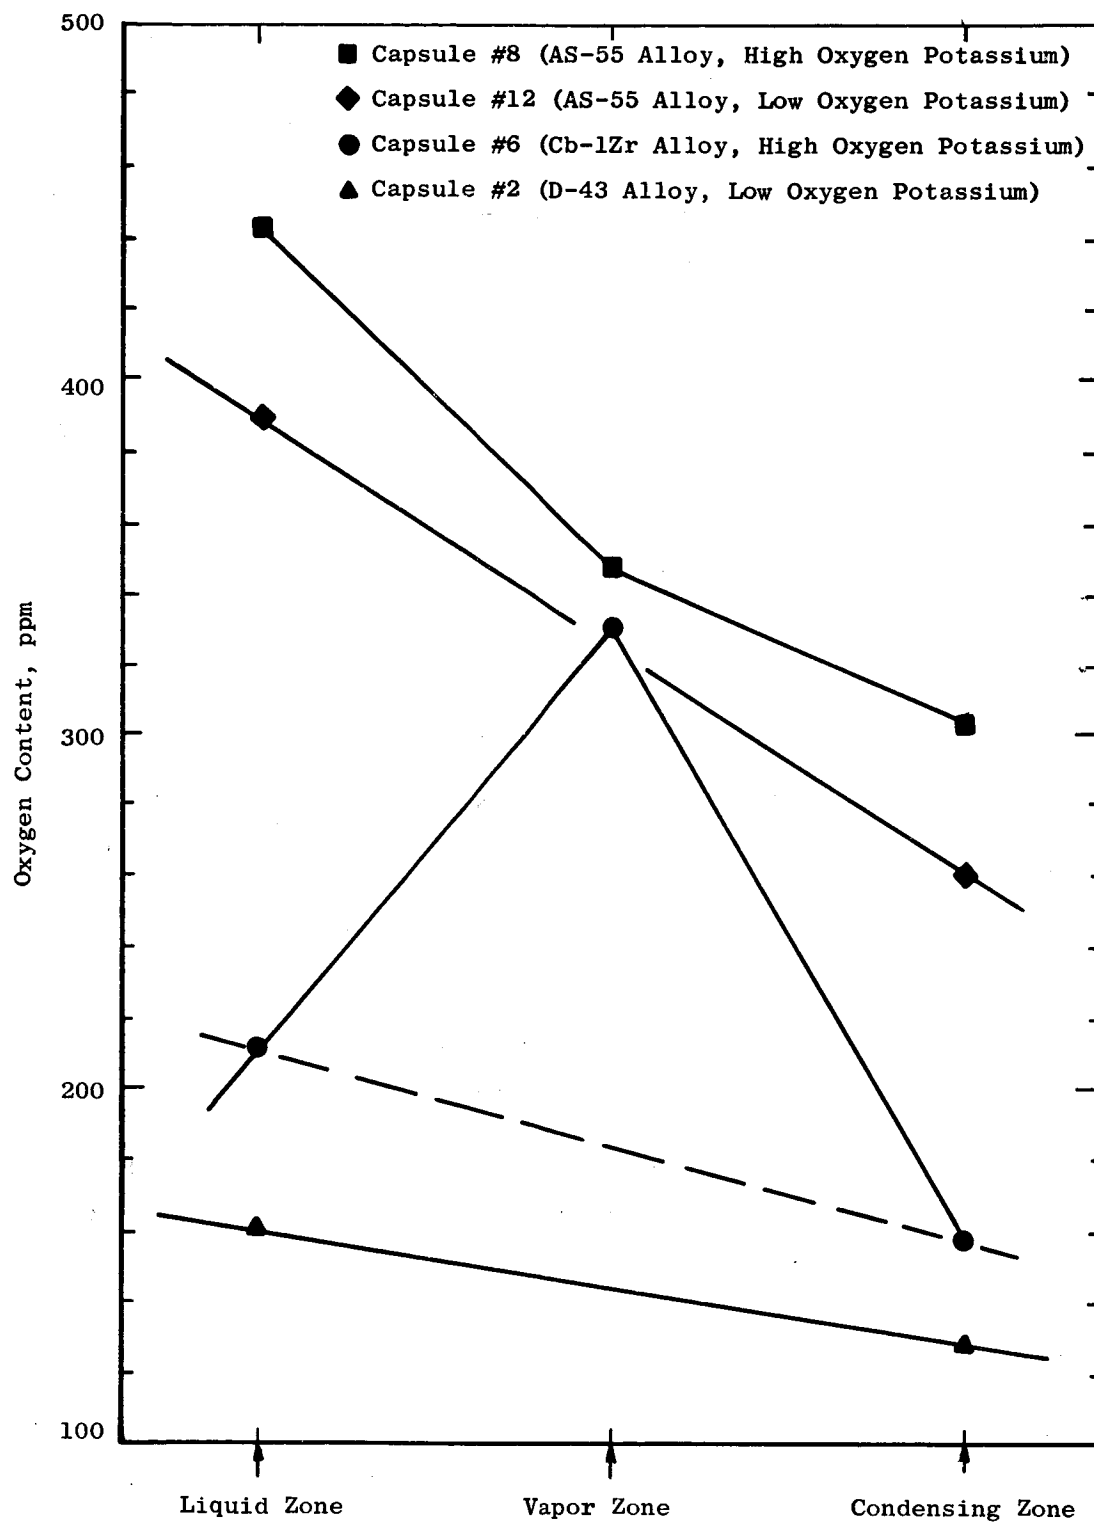
Figure 23. Oxygen Content of Inner 0.040-Inch Layer of Capsule Wall as a Function of Specimen Location. Capsules were Exposed for 5,000 Hours at 2000°F in a Vacuum of  $10^{-9}$  Torr.

In comparing the oxygen analyses obtained from the inner wall specimens, it was found that the oxygen content was always higher in the liquid zone than in the condensing zone, indicating 1) a possible transfer of oxygen from the condensing zone to the liquid zone, 2) removal of the oxygen from the condensing zone by selective leaching by the high-purity condensate and 3) an increase in oxygen content in the liquid zone by a gettering action of the zirconium and yttrium in the columbium. These data are illustrated in Figure 23. From examination of the oxygen analyses of the inner-portion of the capsule walls prior to the 5,000-hour exposure to potassium, it would appear that for the high oxygen-bearing AS-55 alloy, the oxygen was leached from the condenser zone and remained in the liquid potassium as evidenced by the fact that the oxygen was not gettered by the yttrium/zirconium in the AS-55 alloy capsule wall in the liquid zone. It may be hypothesized that the oxygen reacted with yttrium/zirconium taken in solution in the liquid potassium to form finely divided  $\text{Y}_2\text{O}_3$  or a complex yttrium-zirconium oxide. Although the solution of yttrium in potassium has not previously been observed experimentally, yttrium has been shown to be soluble to some extent in a lithium-columbium system at  $1500^\circ\text{F}$ <sup>10</sup>. It also is possible for the oxygen to react with yttrium/zirconium at the surface of the capsule wall in other locations than that which was chemically analyzed. On the other hand, no leaching of the oxygen is apparent in the low oxygen-bearing Cb-1Zr alloy and D-43 alloy capsules, and the increase in oxygen in the inner-capsule wall in the liquid zone is attributed to a gettering action. The high oxygen concentration in the vapor zone of the Cb-1Zr alloy capsule #6 may be the result of the liquid potassium, high in impurities near the liquid-vapor interface, splashing up on the capsule wall. It should be noted that the suspected difference in purity of the potassium used to fill capsule #6 (Cb-1Zr alloy) and #8 (AS-55 alloy) as compared to that used to fill capsules #12 (AS-55 alloy) and #2 (D-43 alloy) does not seem to have an effect on the magnitude of the oxygen gradient observed between the condensing zone and the liquid zone of the capsule after the test exposure.

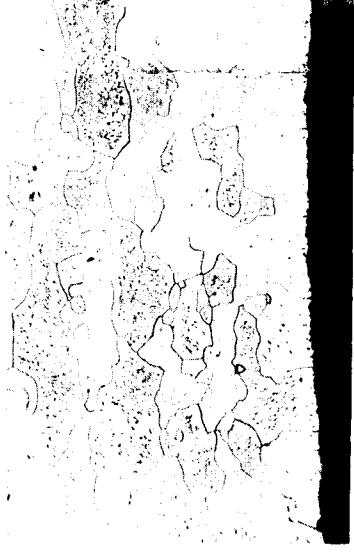
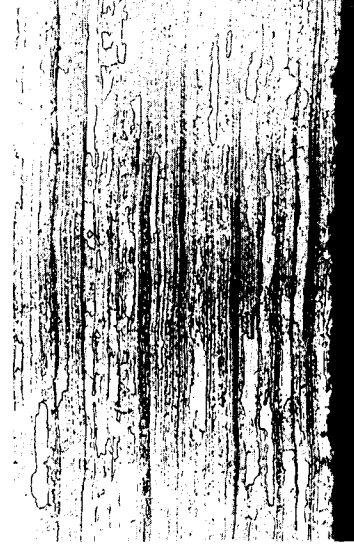
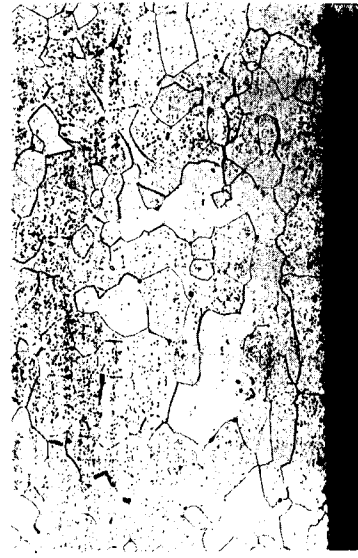
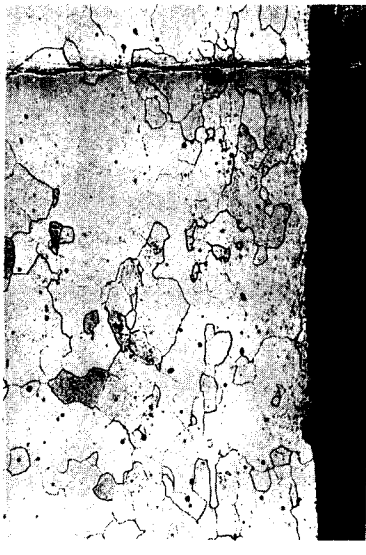
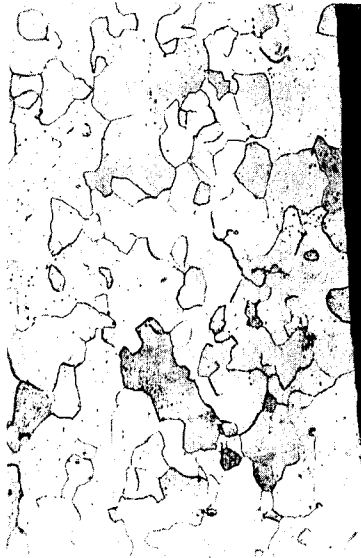
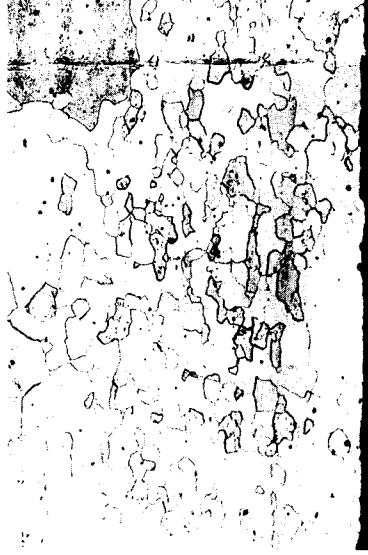
Transverse Section  
of Annealed 0.080-  
Inch Thick Sheet  
Prior to 5,000-Hour  
Exposure

AS-55 Alloy Capsule #8  
High Oxygen Potassium

AS-55 Alloy Capsule #12  
Low Oxygen Potassium

D-43 Alloy Capsule #2  
Low Oxygen Potassium

Transverse Section  
of Condensing Zone  
After 5,000-Hour  
Exposure

Longitudinal Section  
of Liquid-Vapor Inter-  
face After 5,000-Hour  
Exposure

Figure 24. Microstructures of AS-55, D-43 and Cb-1Zr Alloy Reflux  
Corrosion Capsules Prior to and After 5,000-Hour Expo-  
sure to Potassium at 2000°F in a Vacuum of 10<sup>-9</sup> Torr.  
Etchant: 20%Hf-20%HNO<sub>3</sub>-60%Water Original Mag: 250X

No significant attack was observed in any of the capsules, Figure 24. The AS-55 alloy capsule #8, that contained potassium which is believed to have had a high concentration of oxygen, showed a slight amount of general solutioning in the liquid zone; this was not evident in the AS-55 alloy capsule #12 that contained potassium of higher purity, Figure 24 (see page 56). A morphological change was observed in the AS-55 alloy. The Widmanstätten structure seen in the matrix of the pre-test AS-55 alloy sheet material has gone into solution and a grain boundary precipitate now exists. Through stain etching techniques, the grain boundary precipitate was tentatively identified as a columbium carbide.

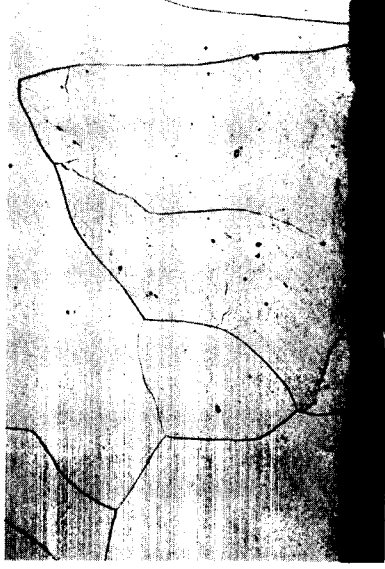
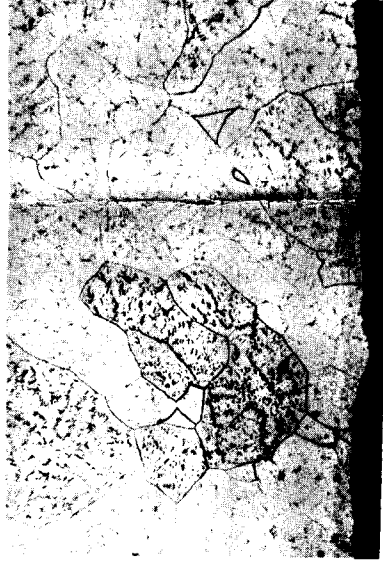
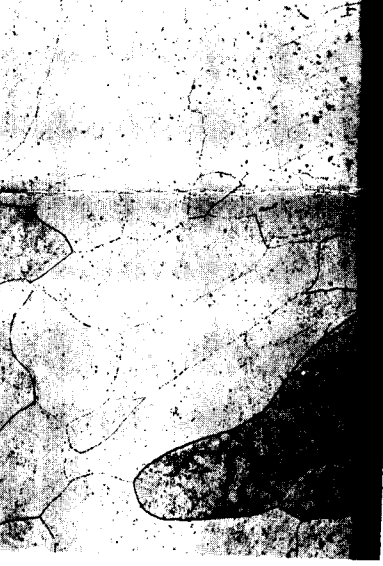
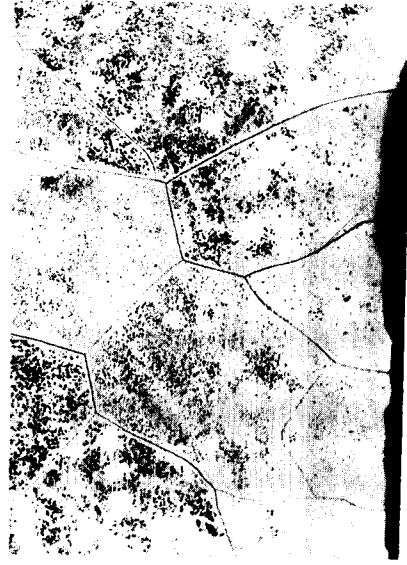
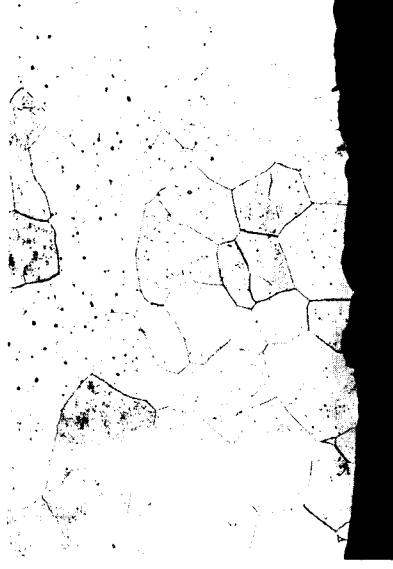
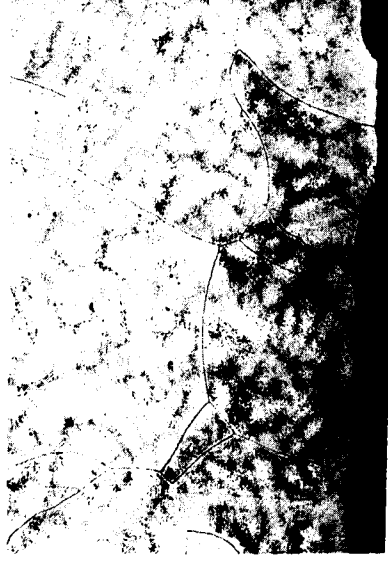
Figure 25. Microstructure of Welds in AS-55, D-43 and Cb-1Zr Alloy  
Reflux Corrosion Capsules Prior to and After 5,000-Hour  
Exposure to Potassium at 2000°F in a Vacuum of 10-9 Torr.  
Etchant: 20%Hf-20%HNO<sub>3</sub>-60%Water Original Mag: 250X

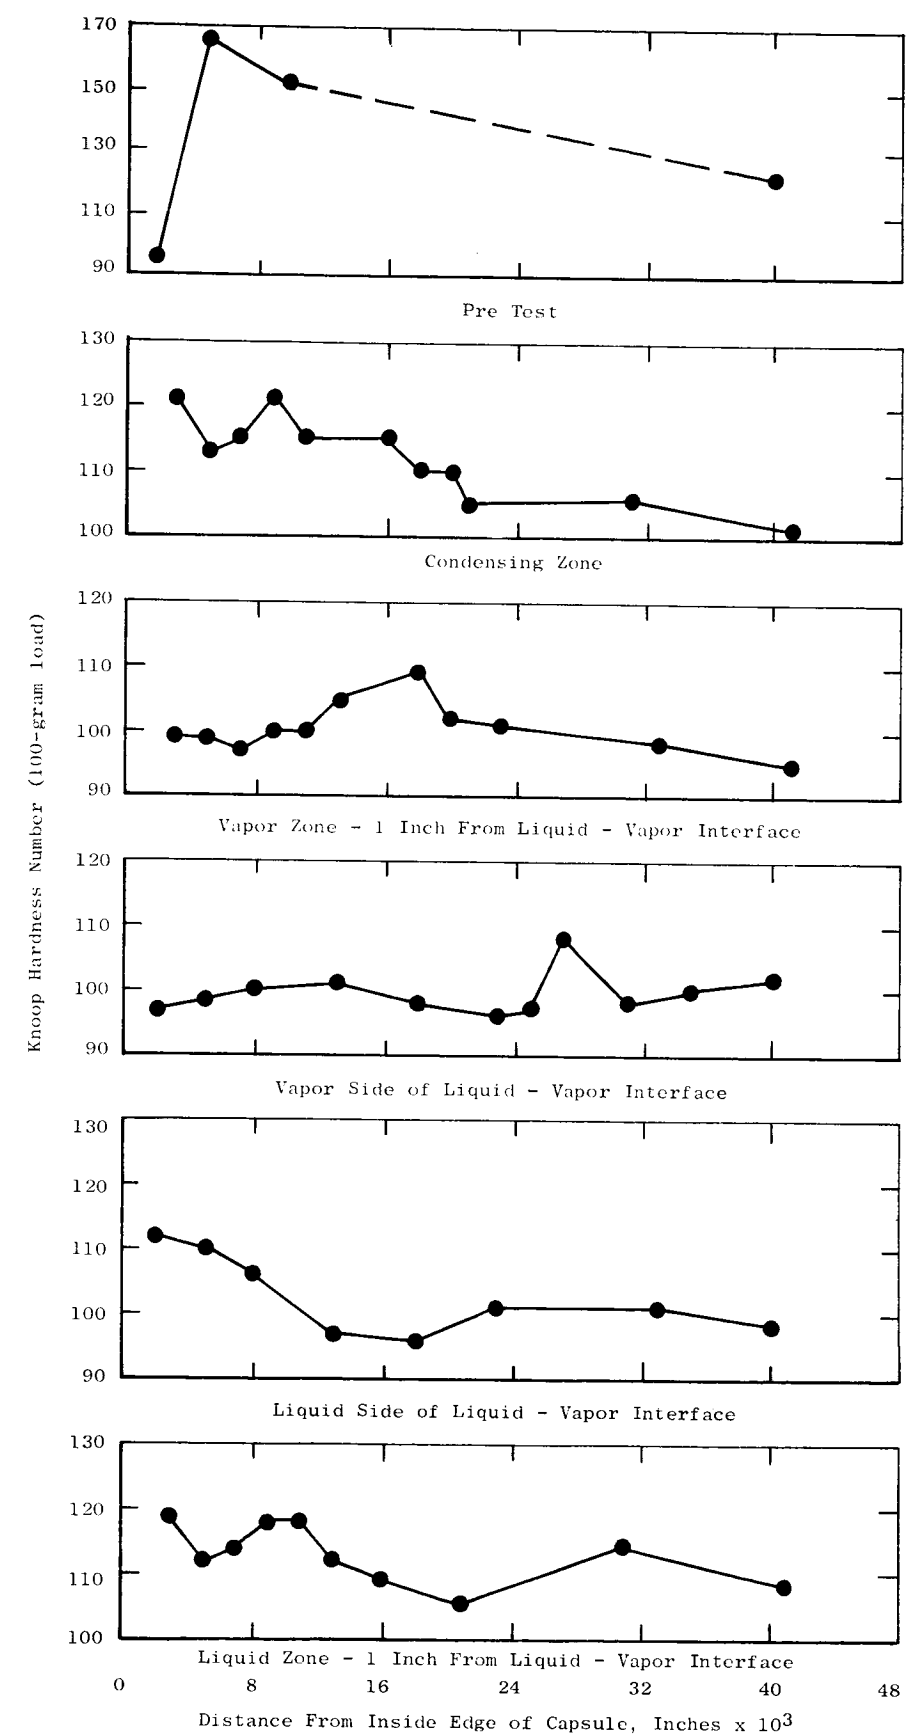
Figure 26. Microhardness Traverses of Transverse Sections of Cb-1Zr Alloy Reflux Corrosion Capsule #6 After 5,000-Hour Exposure to Potassium at 2000°F in a Vacuum of  $10^{-9}$  Torr.

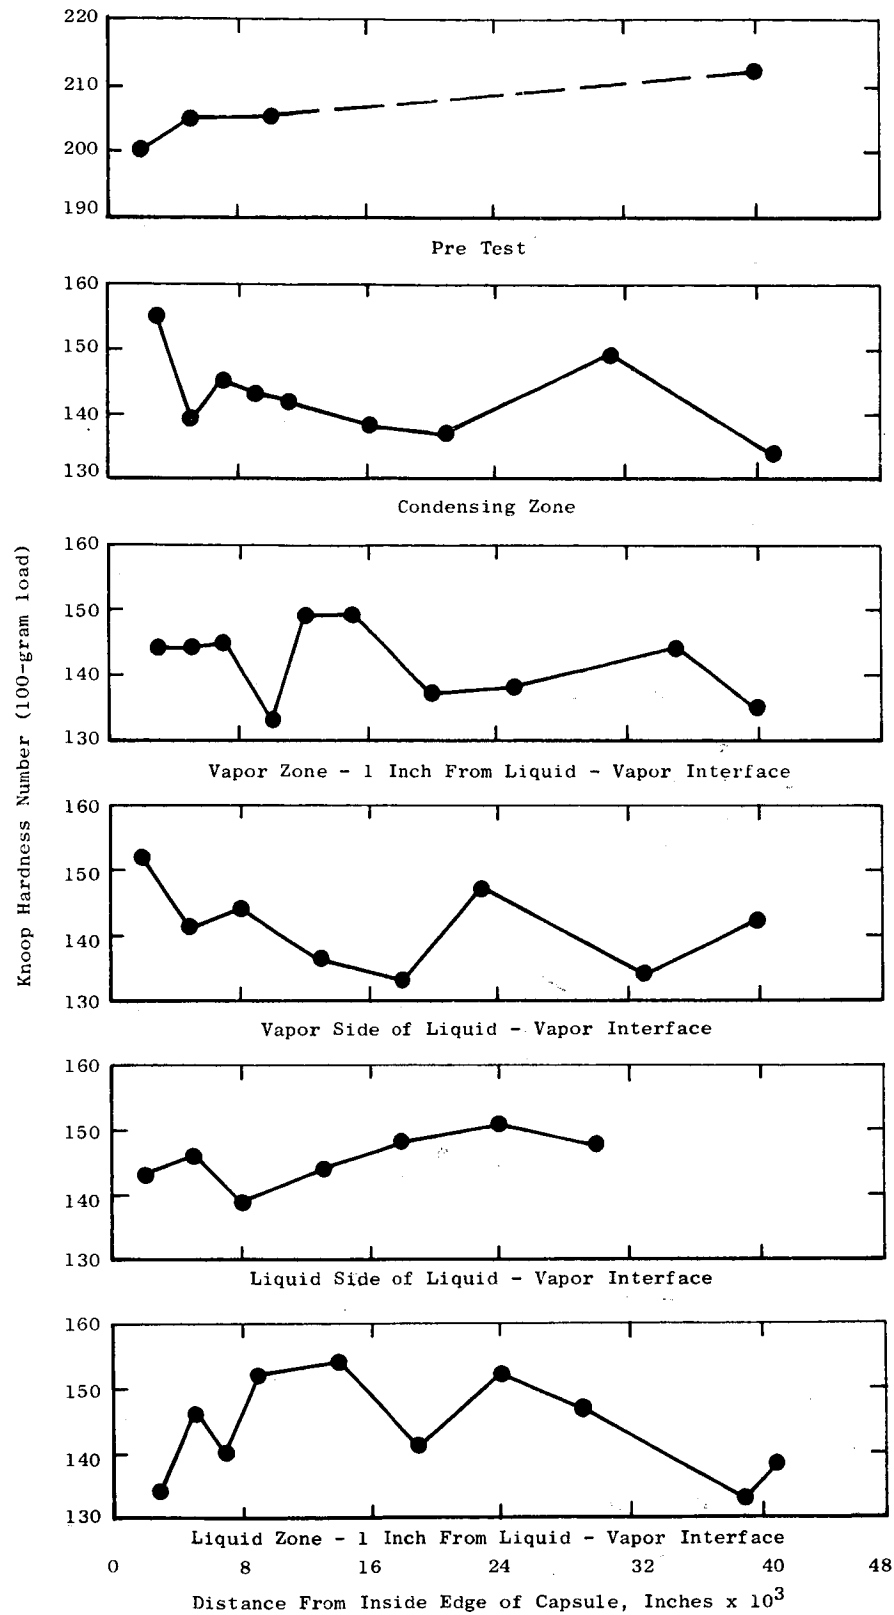
Figure 27. Microhardness Traverses of Transverse Sections of AS-55 Alloy Reflux Corrosion Capsule #8 After 5,000-Hour Exposure to Potassium at 2000°F in a Vacuum of  $10^{-9}$  Torr.

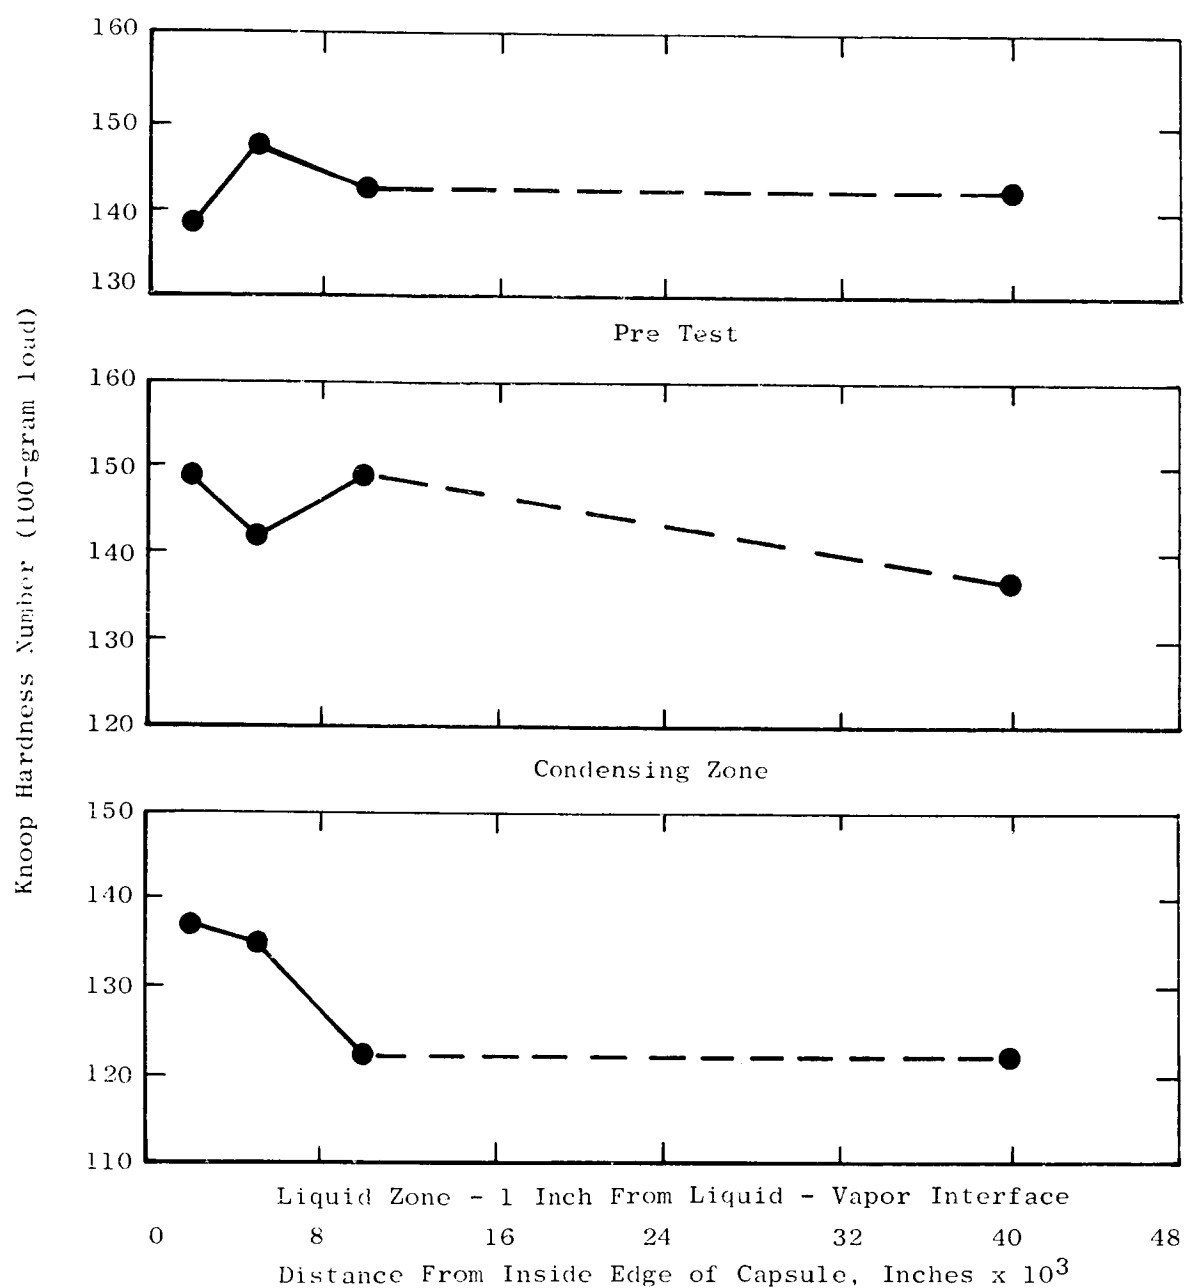
Figure 28. Microhardness Traverses of Transverse Sections of AS-55 Alloy Reflux Corrosion Capsule #12 After 5,000-Hour Exposure to Potassium at 2000°F in a Vacuum of  $10^{-9}$  Torr.

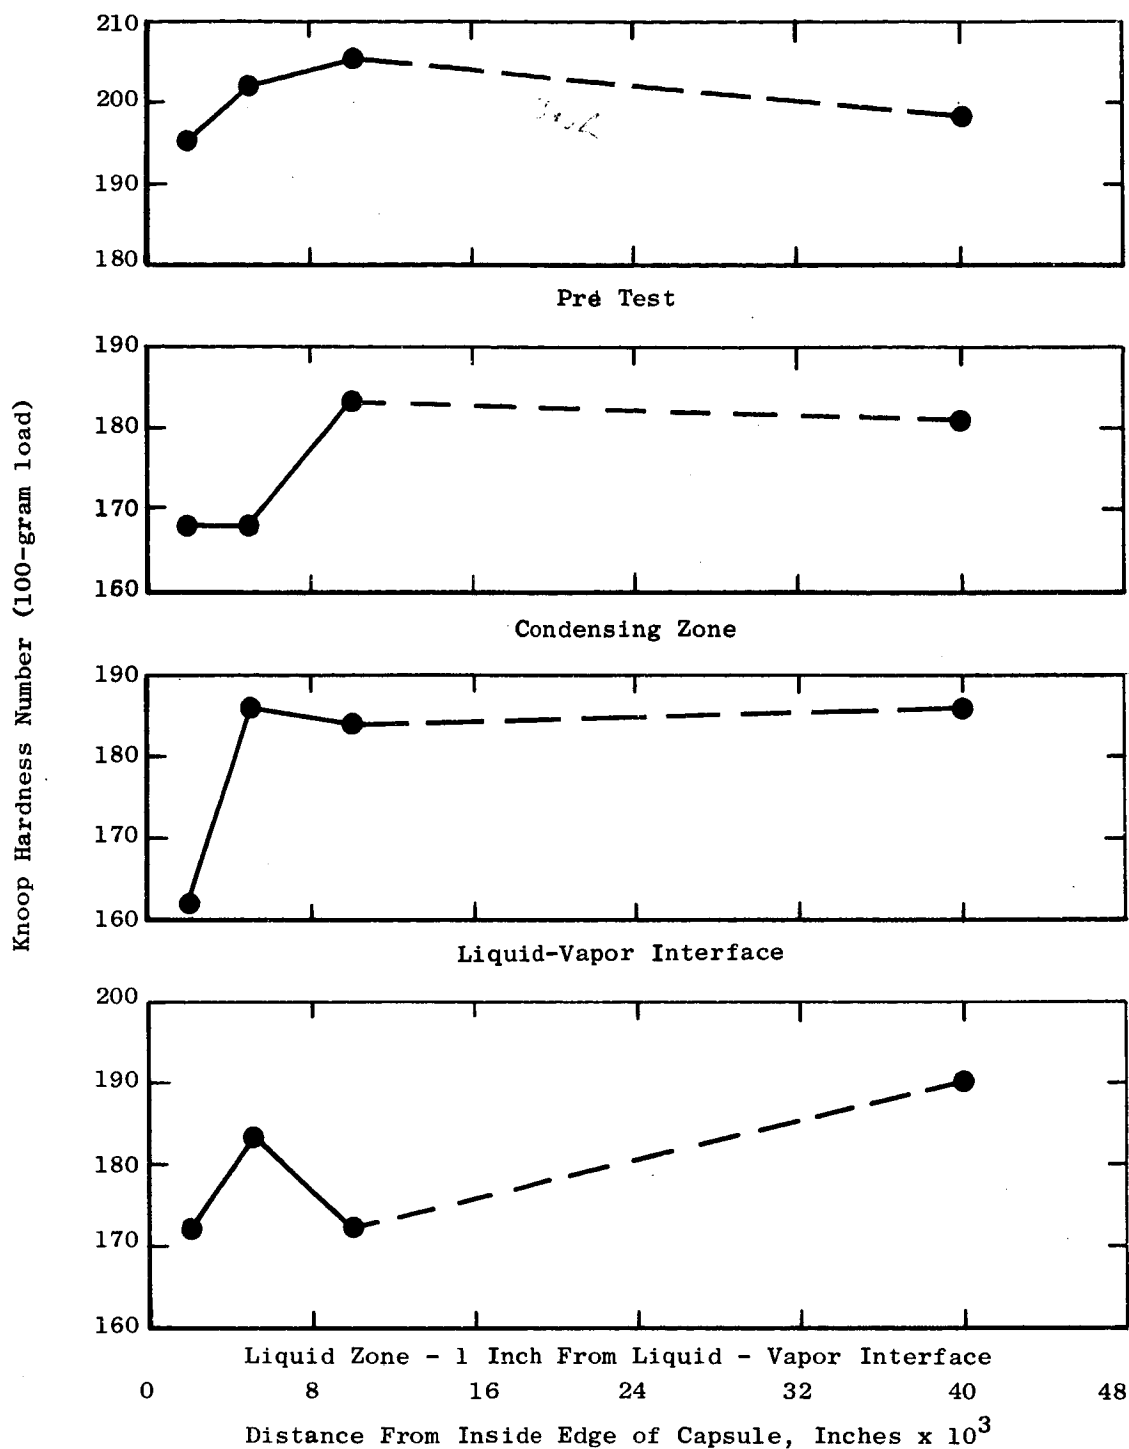
Figure 29. Microhardness Traverses of Transverse Sections of D-43 Alloy Reflux Corrosion Capsule #2 After 5,000-Hour Exposure to Potassium at 2000°F in a Vacuum of  $10^{-9}$  Torr.
